Quality Home Inspections, Inc.
Property Inspection Report

1001 Apple Grove Road, Lynchburg, VA 24504
Inspection prepared for: James Elliott
Date of Inspection: 10/29/2015 Time: 12.30
Age of Home: 7 Years Old
Weather: Partly Cloudy

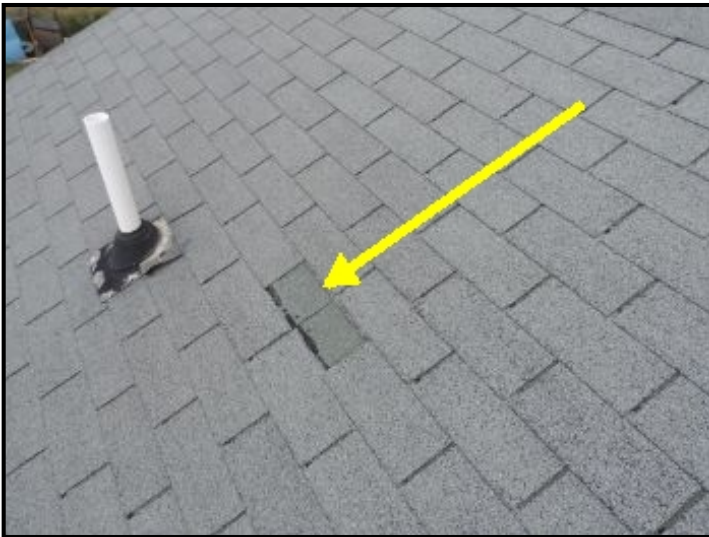
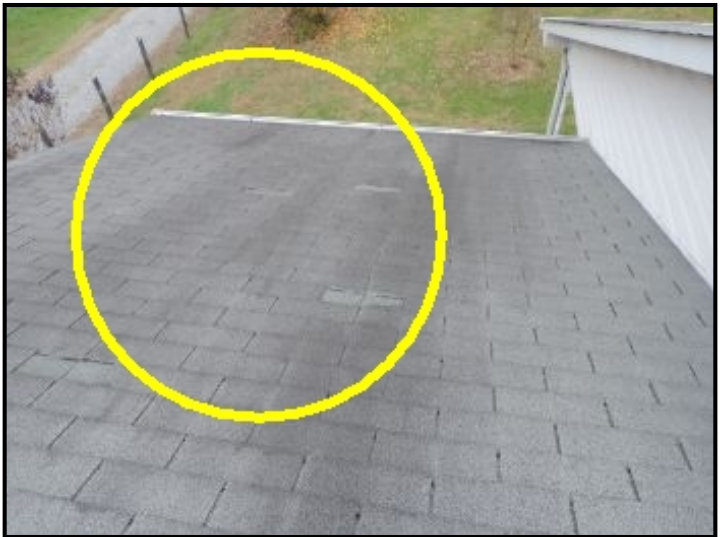
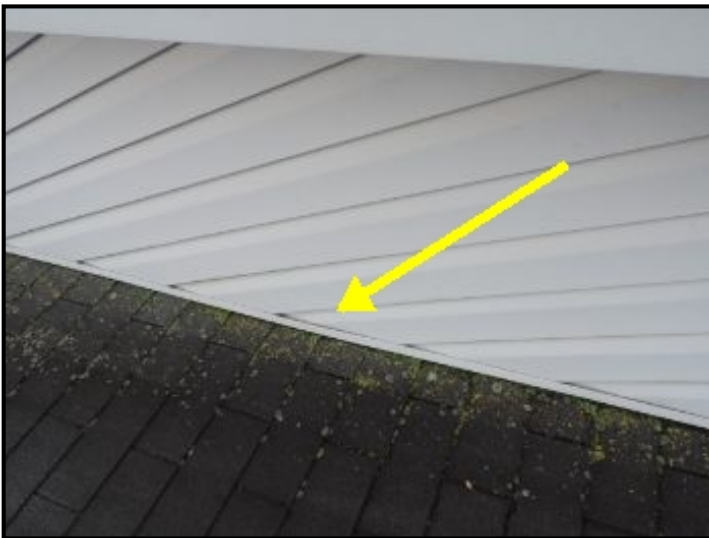
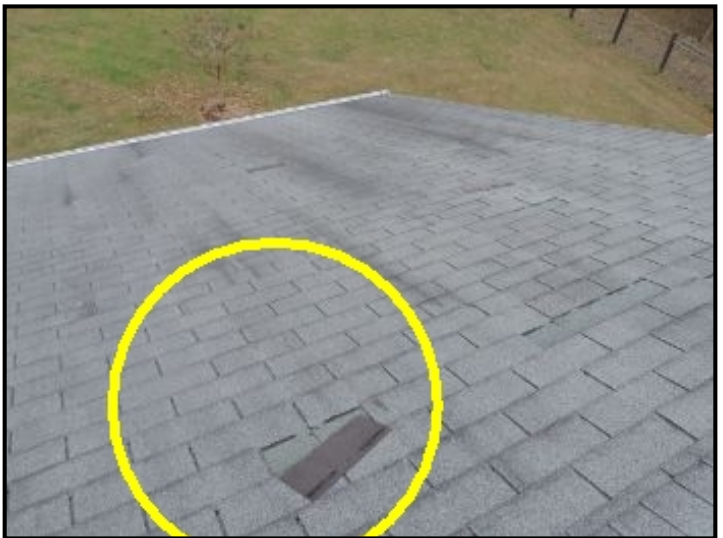
- Moss on roof. This can lead to the premature failure of the roof and subsequent leaks. Recommend treating moss during its growing season (wet months) with a moss killer. For information on various moss treatment products and their pros and cons, visit <http://bryophytes.science.oregonstate.edu/page24.htm>.
- Some shingles &/or tabs missing.

moss on roof

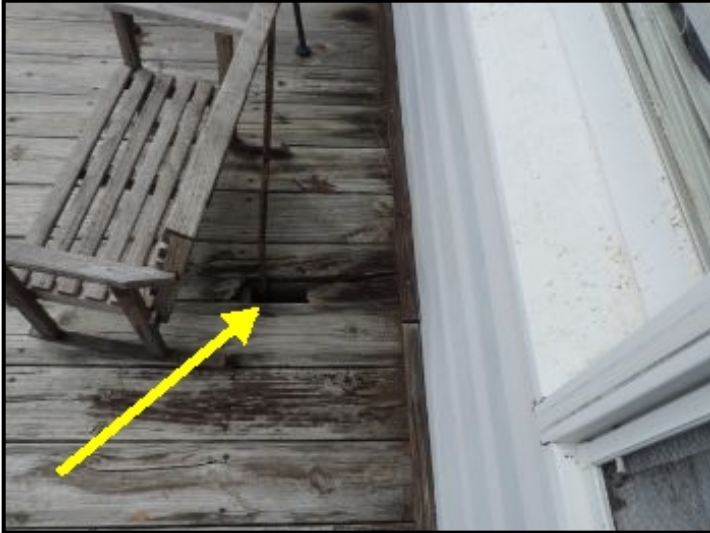
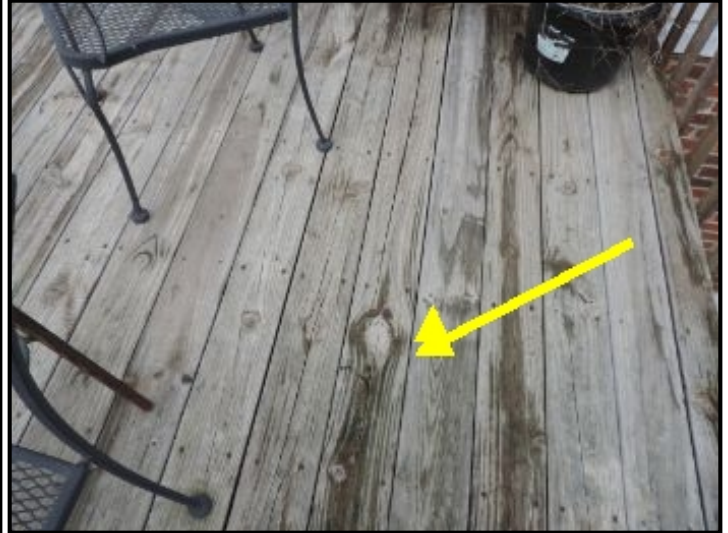
Observations:
• No major system safety or function concerns noted at time of inspection.
